KENNEBEC - ANDROSCOGGIN RIVER BASIN
WILTON, MAINE

WILSON POND DAM
ME 00121

PHASE I INSPECTION REPORT
NATIONAL DAM INSPECTION PROGRAM

MARCH 1980

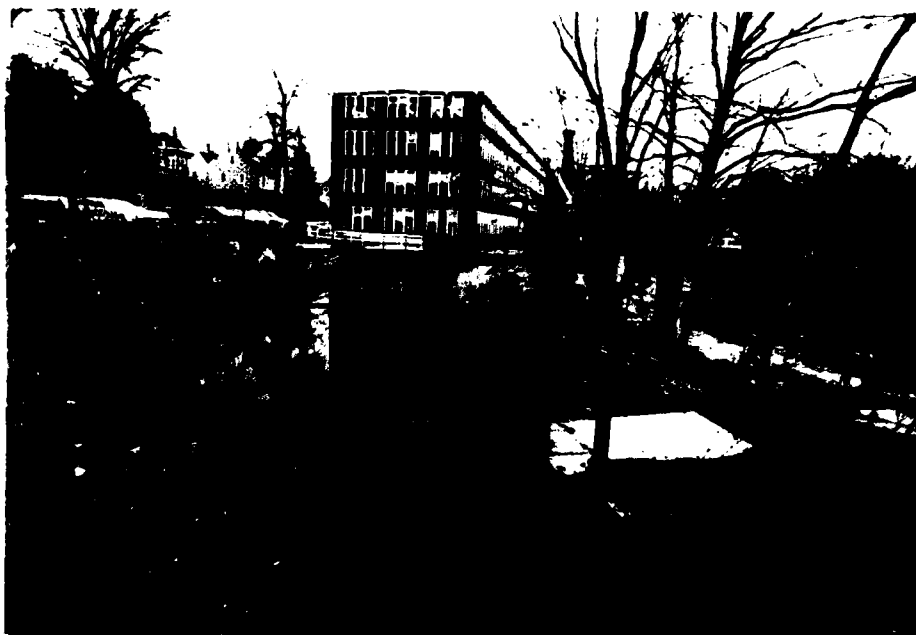
c. Appurtenant Structures. The power canal, Photo No. 10, is in fair condition with several local failures of the stone walls along the canal. Minor brush is present along

10. Power canal downstream from intake structure

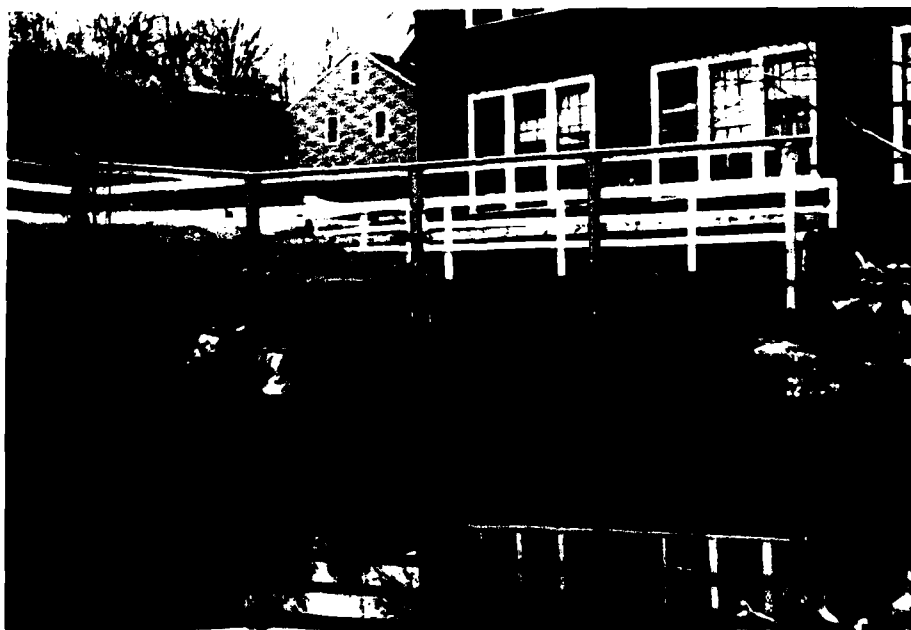
The wooden access bridge and area adjacent to the forebay are in good condition, Photo No. 11. The debris rack over the intake of the shoe factory power tunnel, though rusted, is considered to be in good condition and was free of debris.

11. Power tunnel forebay with access bridge
